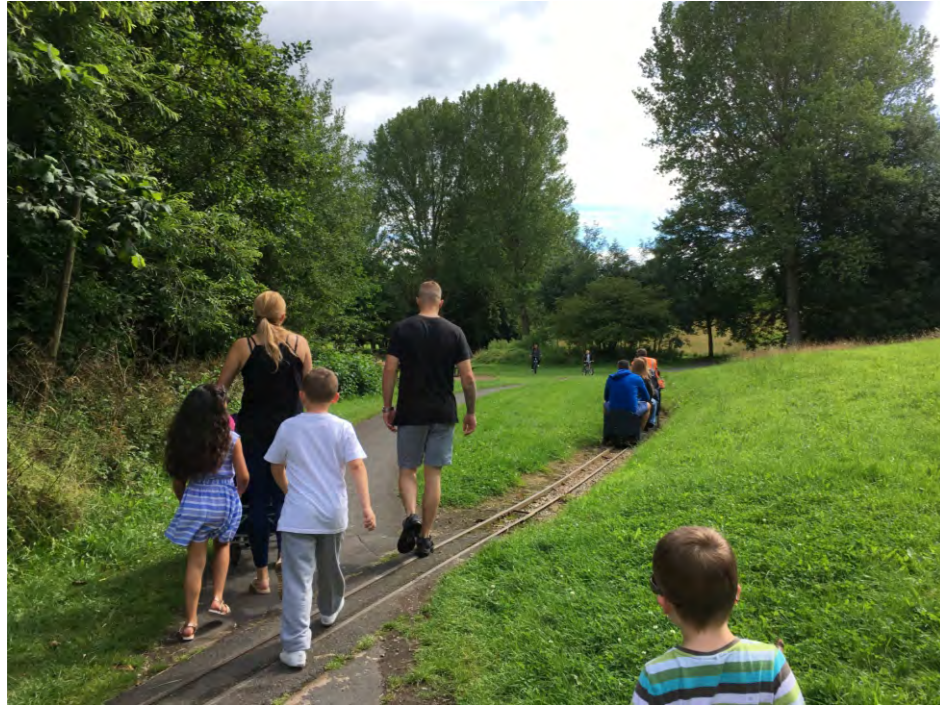
1. Original park footpaths and cycle routes are of insufficient width for current level of usage.

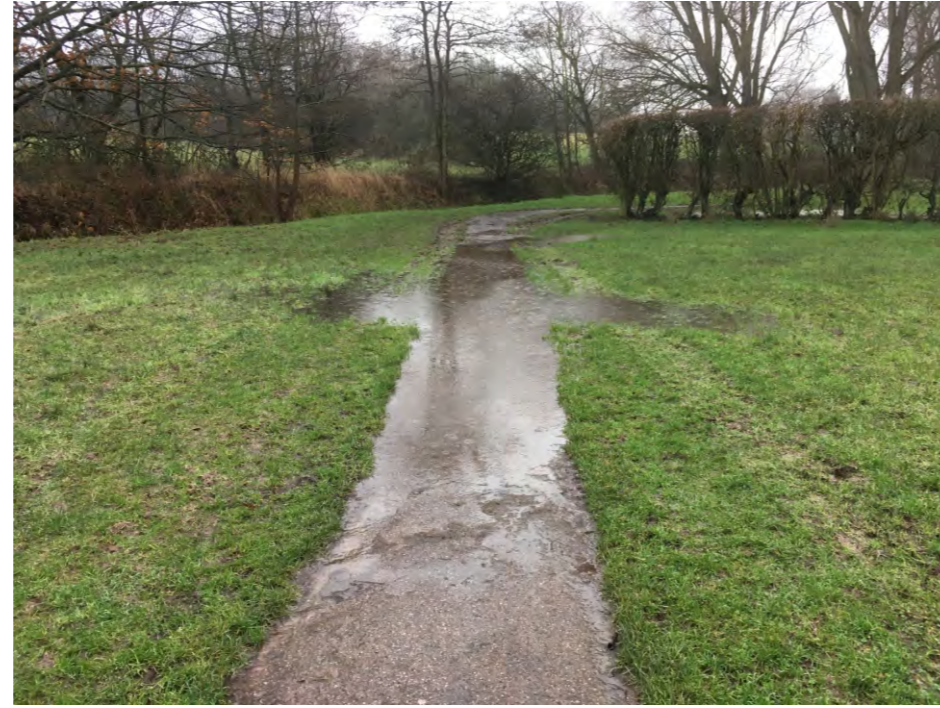
2. Footpath drainage problems.

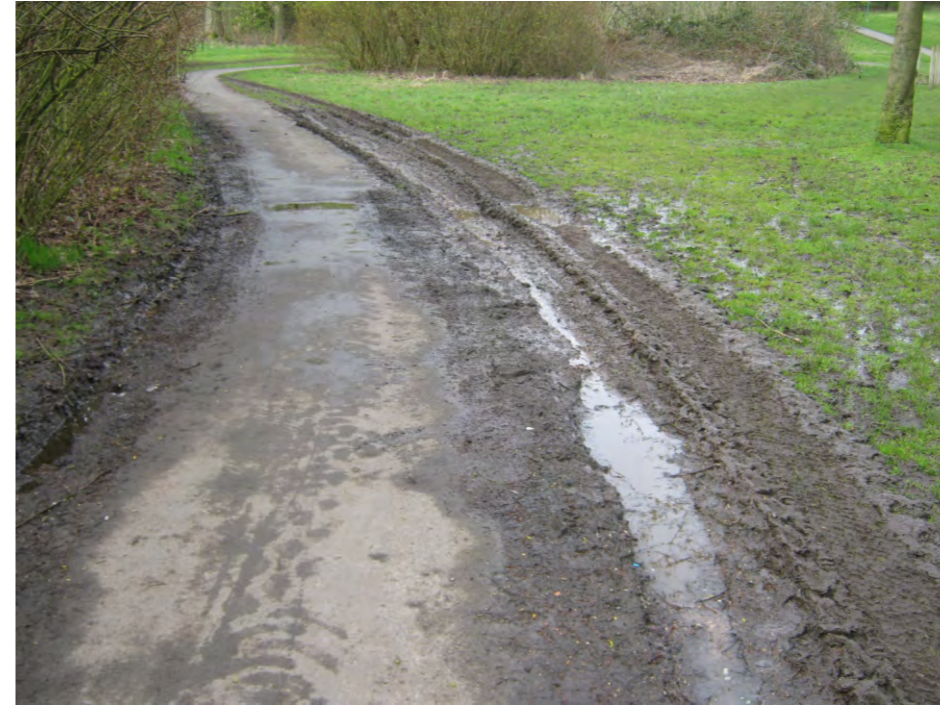
3. Existing path surfacing of insufficient width to allow for maintenance access through the park.

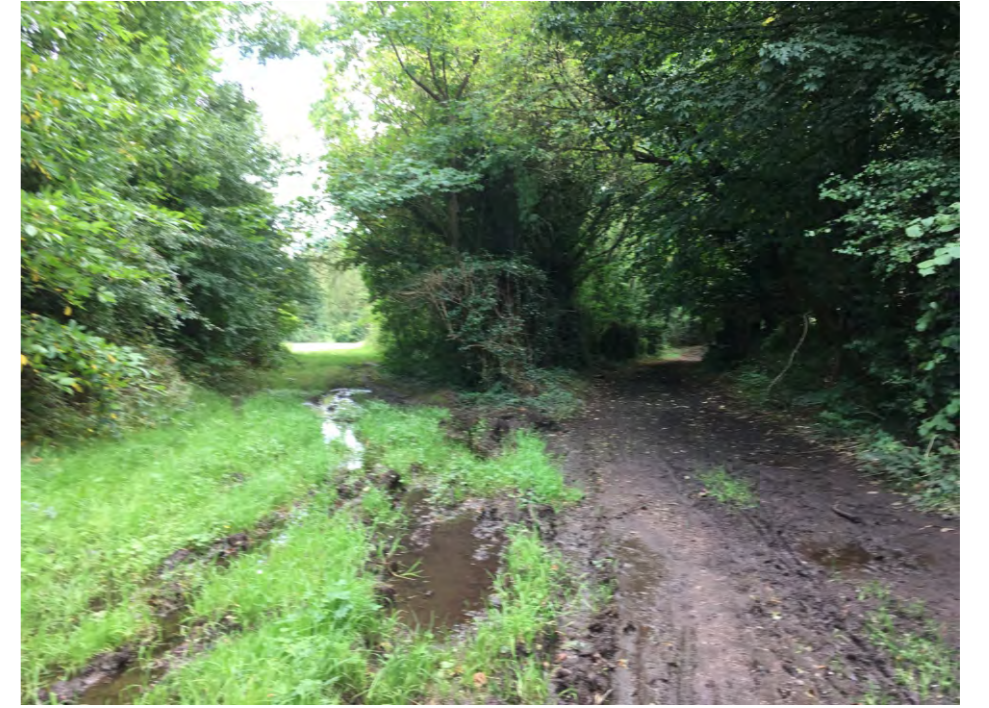
4. Lack of path surfacing connecting routes through the park.

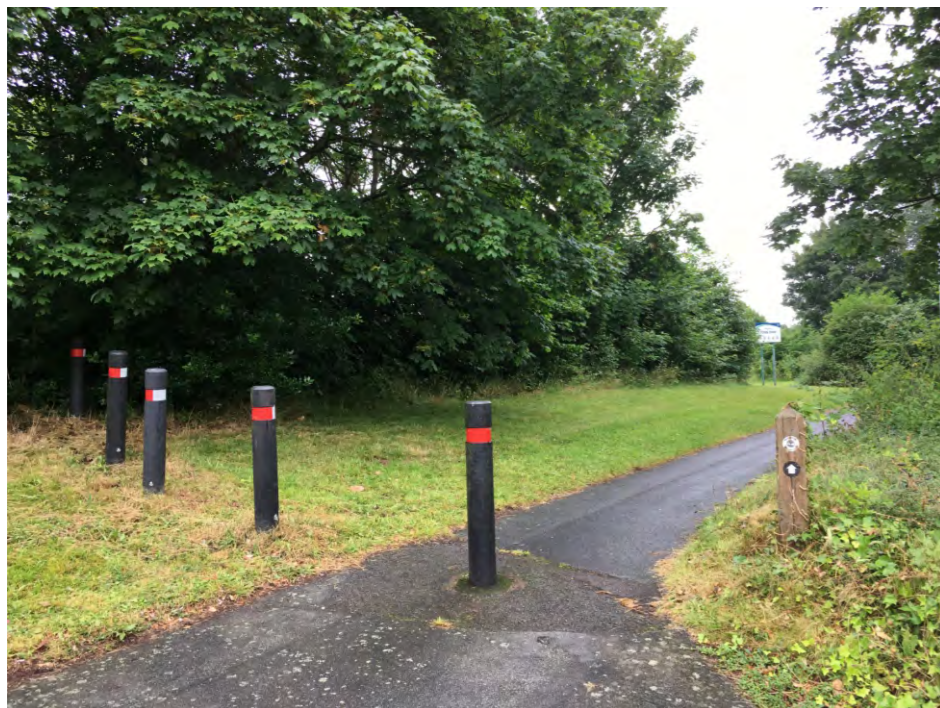
5. Poor impression - entrance to Town Park from Holt Lane and Shopping City.

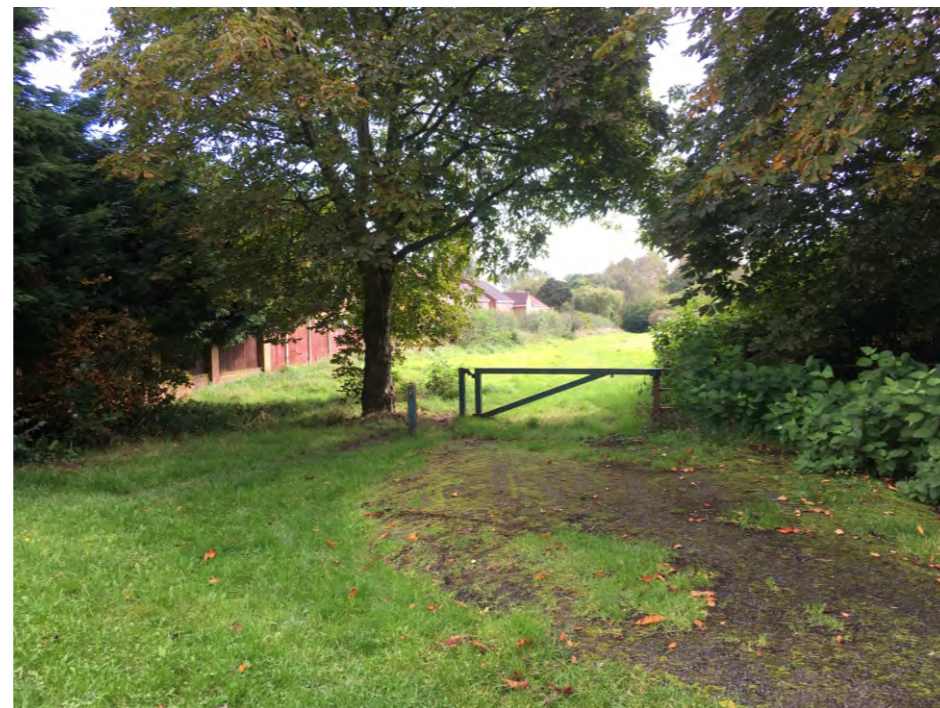
6. Lack of entrance definition - Town Park from Palace Fields Avenue.

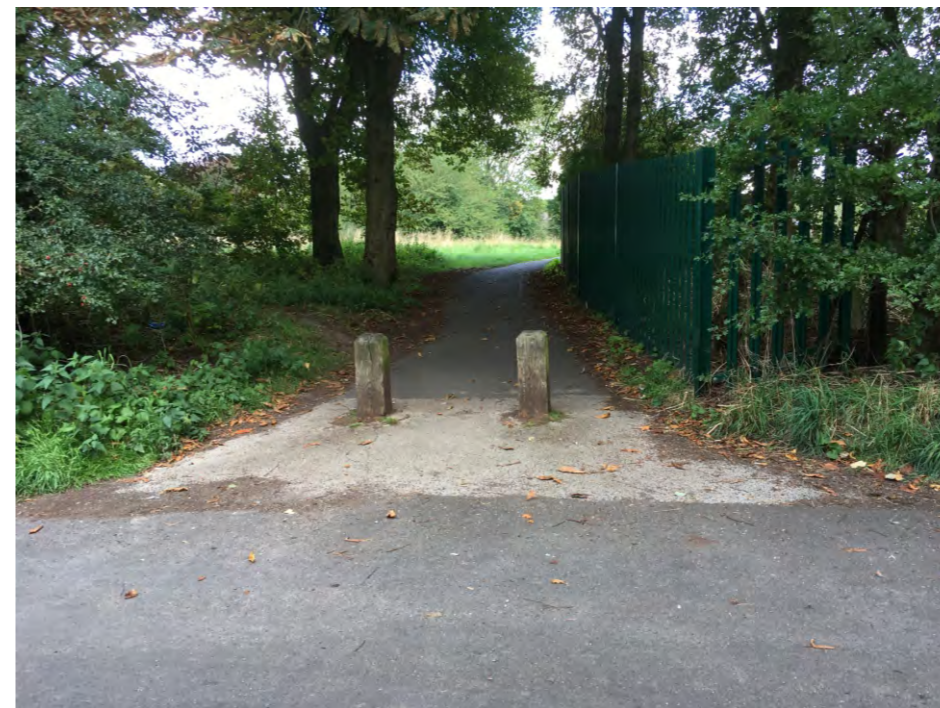
7. Lack of signage - pedestrian entrance to Town Park from Stockham Lane.

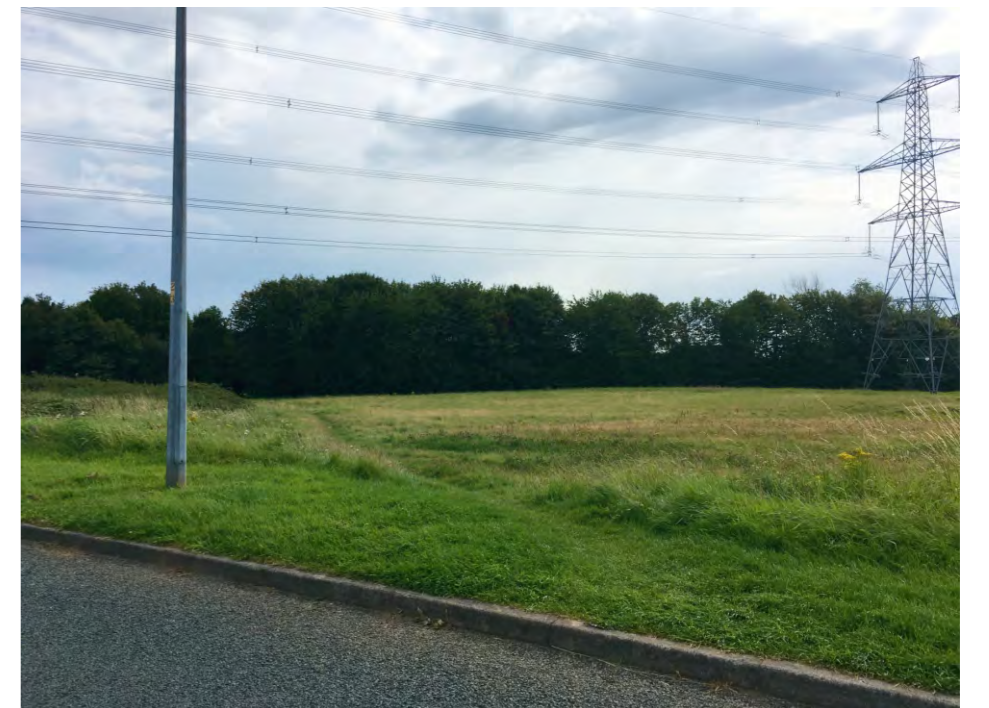
8. Lack of protection - the boundary to the park along Tower Lane.

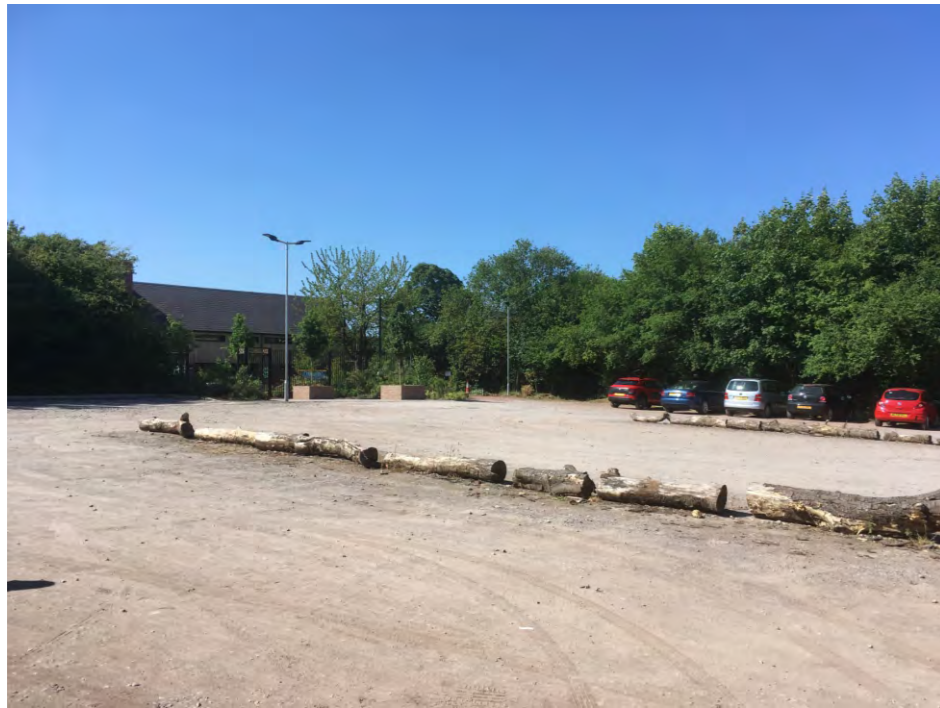
9. Poor arrival experience - existing unsurfaced car park at Norton Priory.

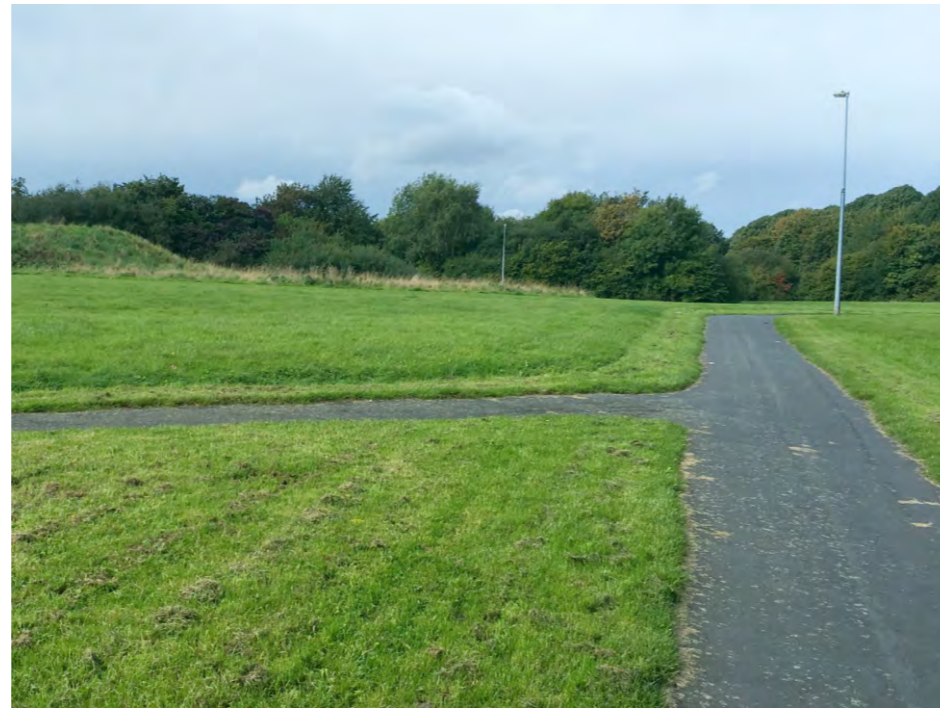
10. Lack of directional signage - existing footpath cycleway towards Halton Lea.

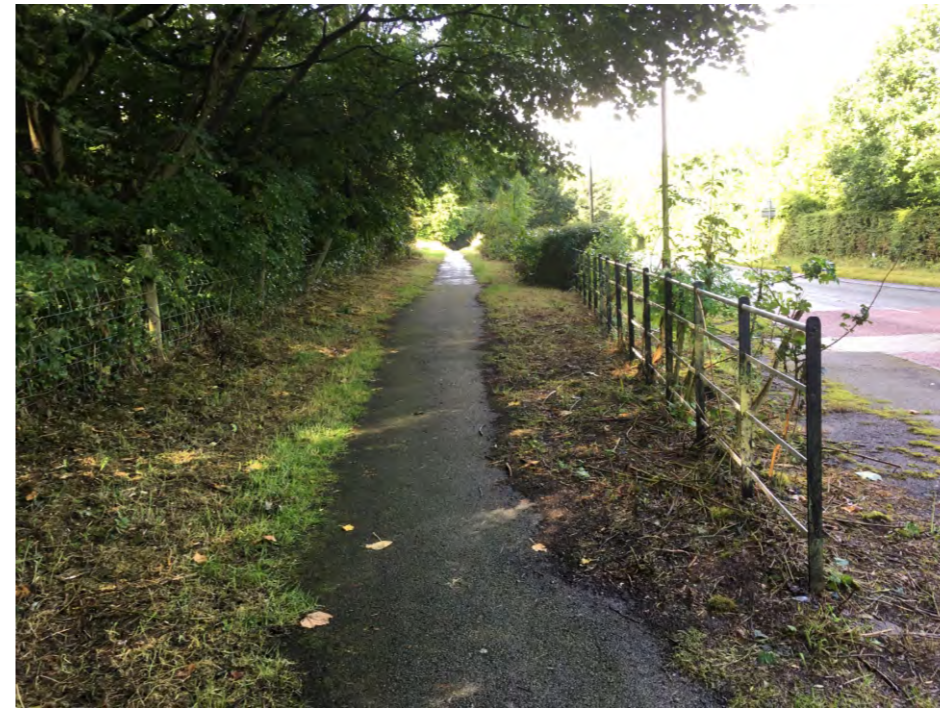
11. Poor connections through the park across the Busway.

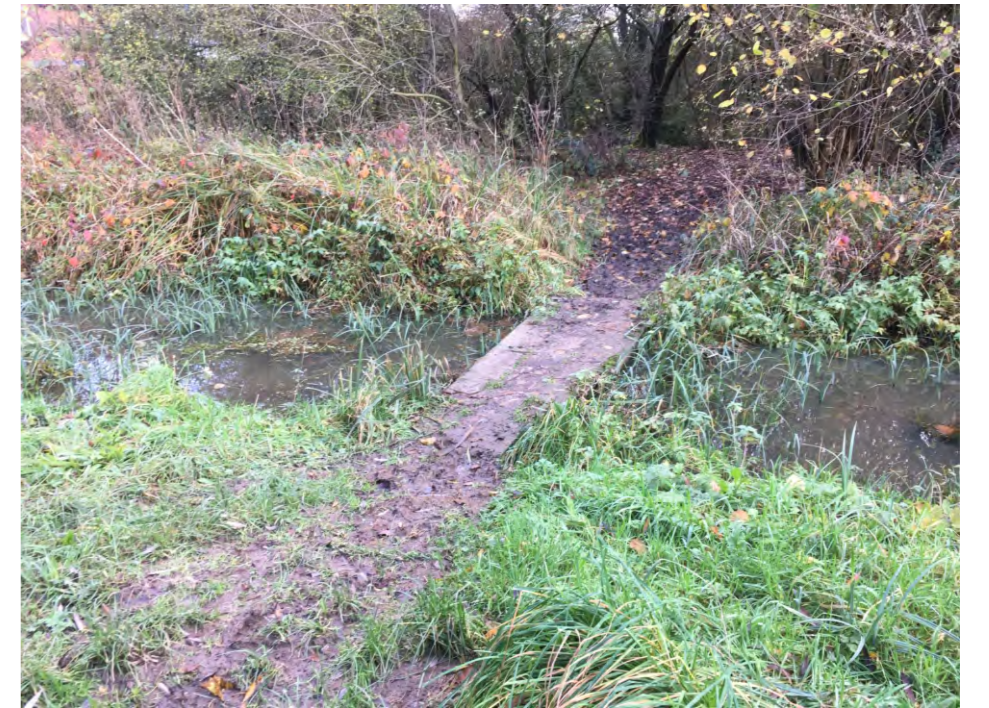
12. Low quality bridged connection linking the park to local neighbourhoods.

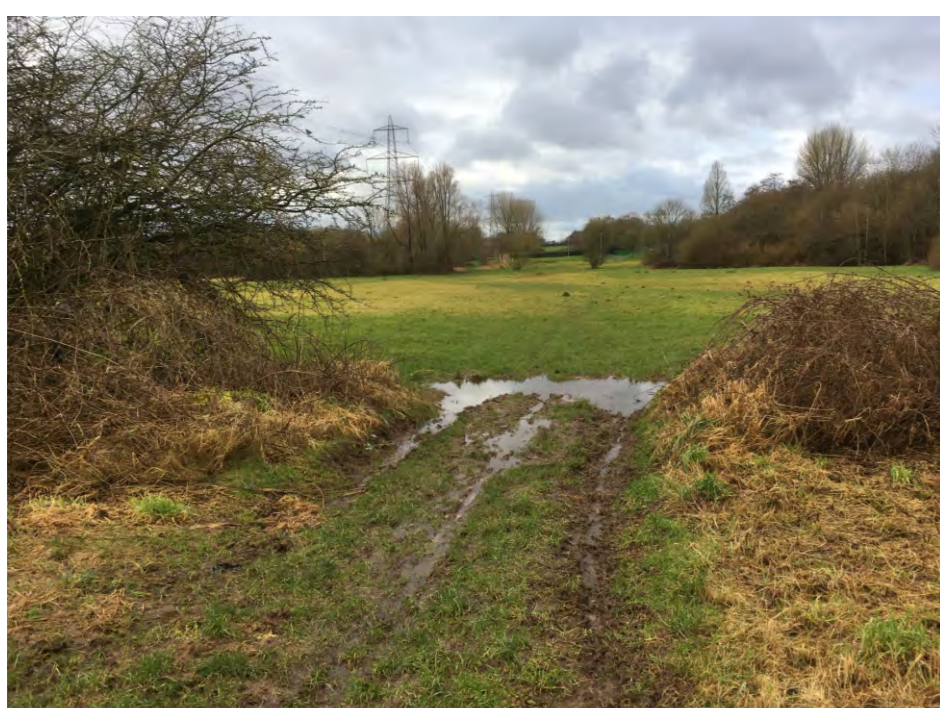
13. Lack of maintenance access and poor path connections through the meadows.

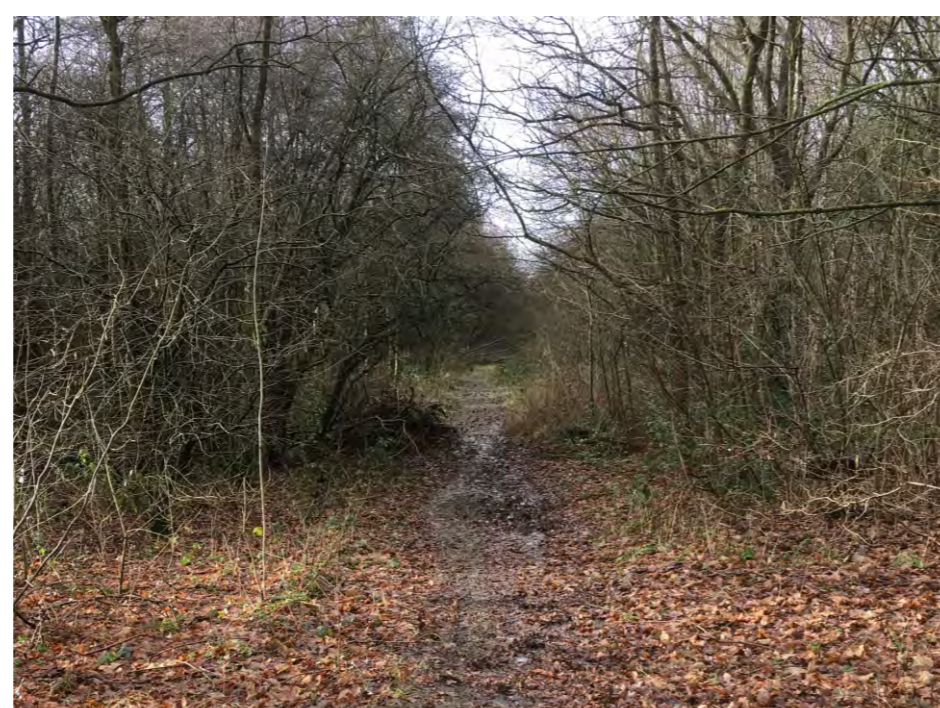
14. Opportunity for improved woodland access including interpretational signage.

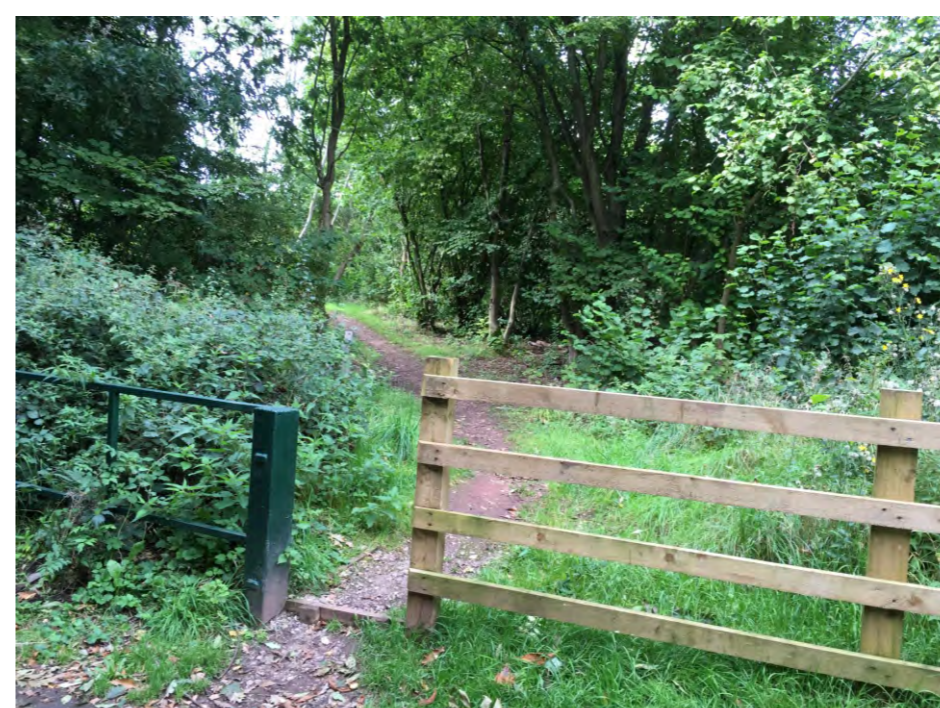
15. Opportunity for improved links with Woodland Trust owned woodlands.

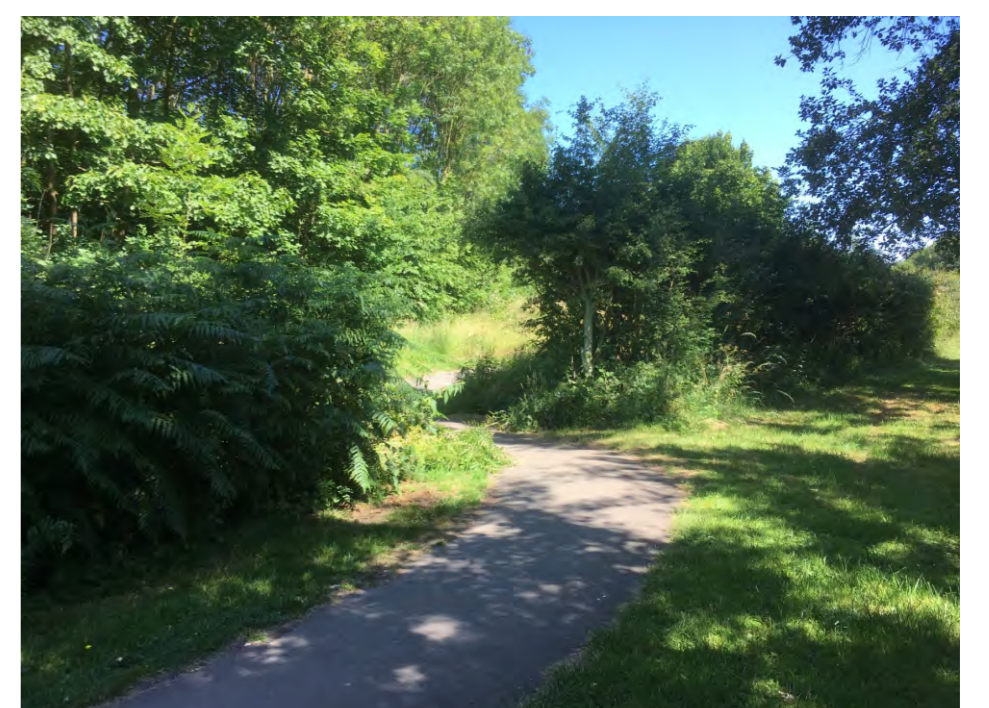
16. Original mature hedgrows restricting visibility along footpath and cycle routes.

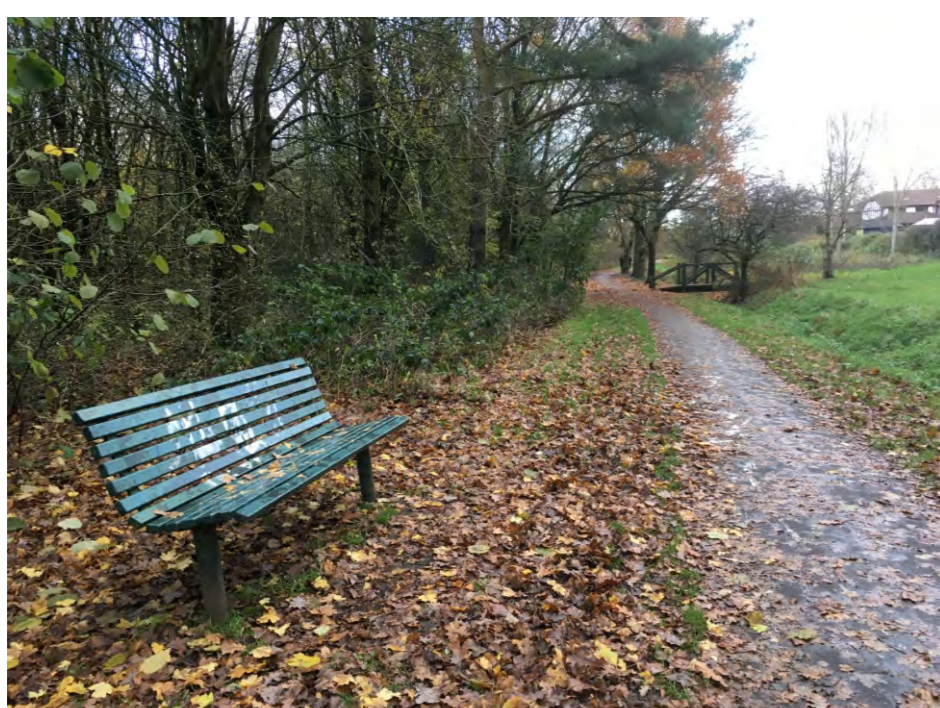
17. Existing seating in poor condition. Lack of seating in some areas.

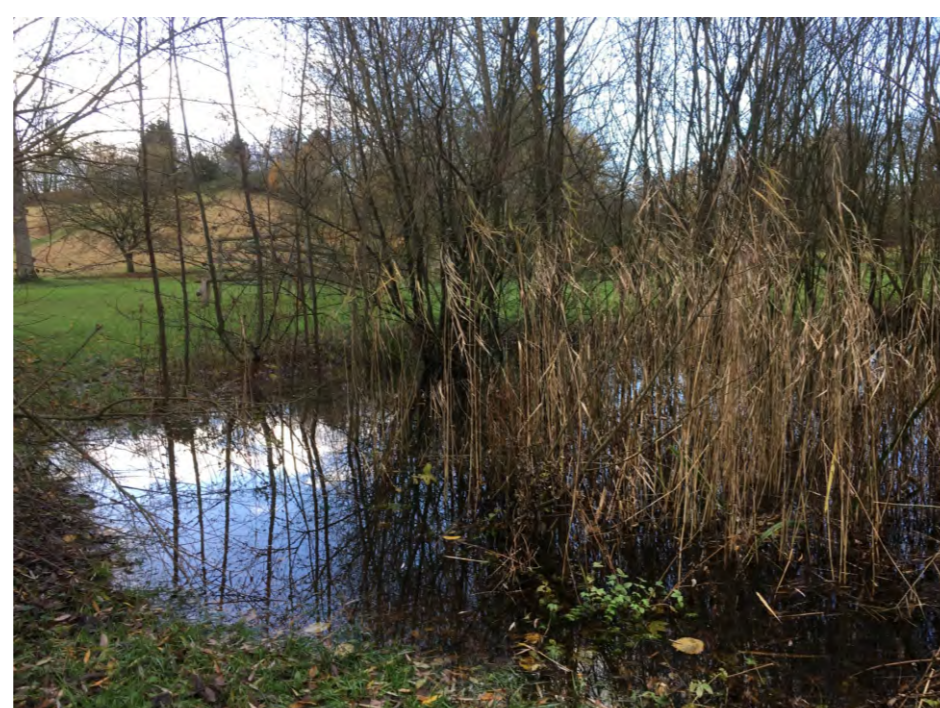
18. Overgrown vegetation obscuring and reducing capacity of ponds.

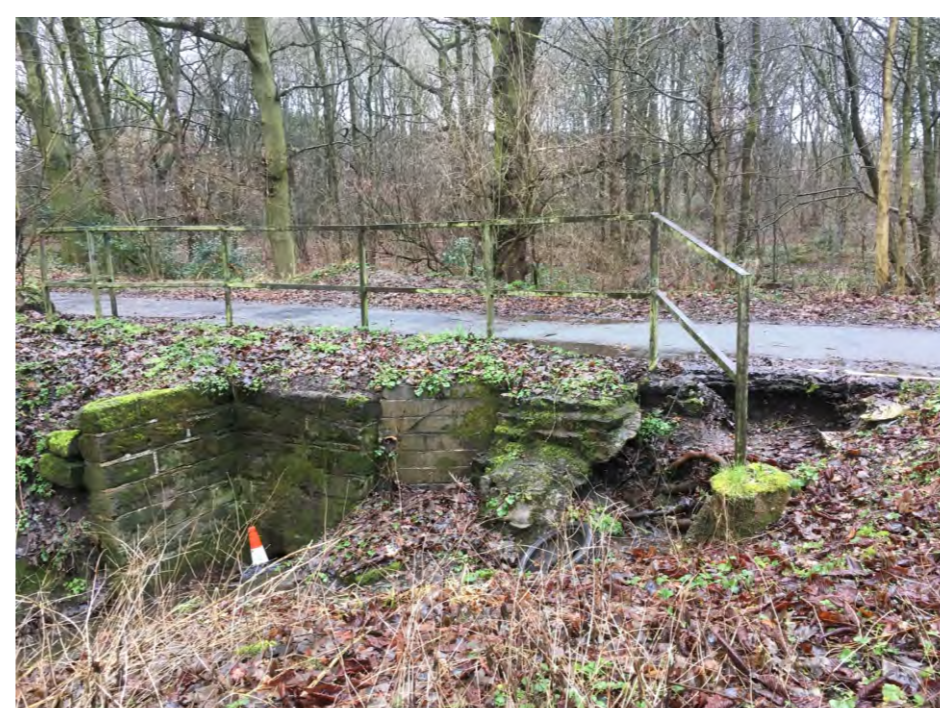
19. Existing brook headwall in poor condition.

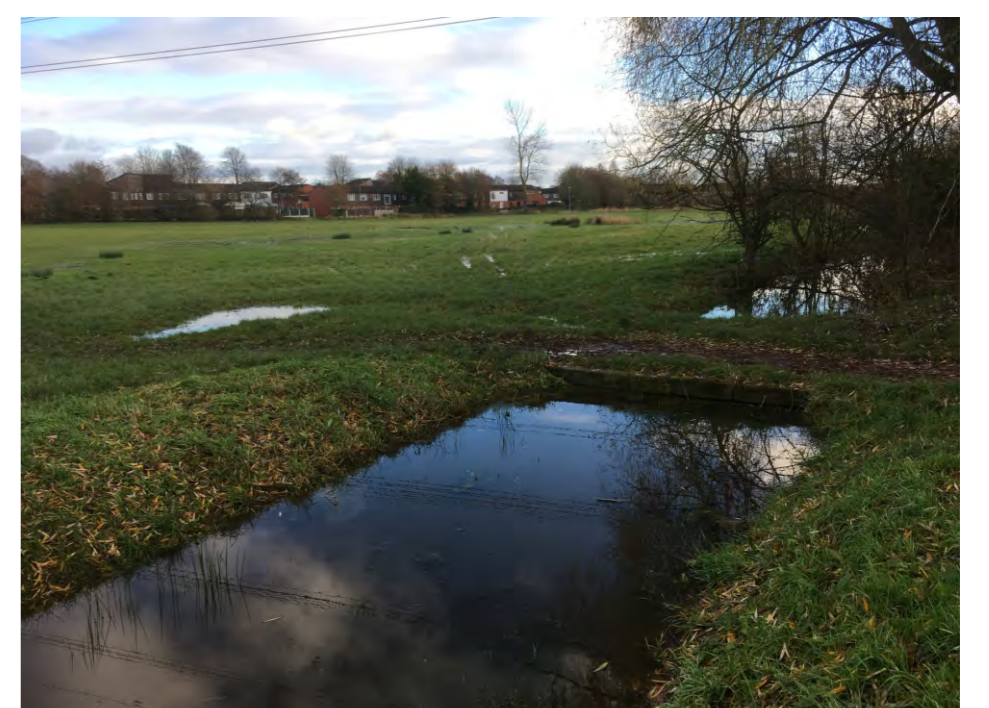
20. Ditches at full capacity.
