Halton Village Conservation Area Appraisal and Management Plan

**HALTON VILLAGE
CONSERVATION AREA
APPRAISAL AND
MANAGEMENT PLAN
PUBLIC CONSULTATION
DRAFT 2008**

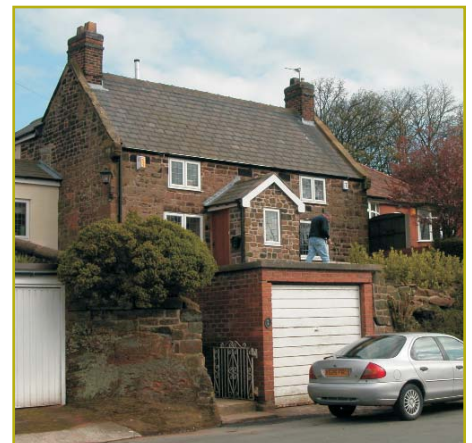
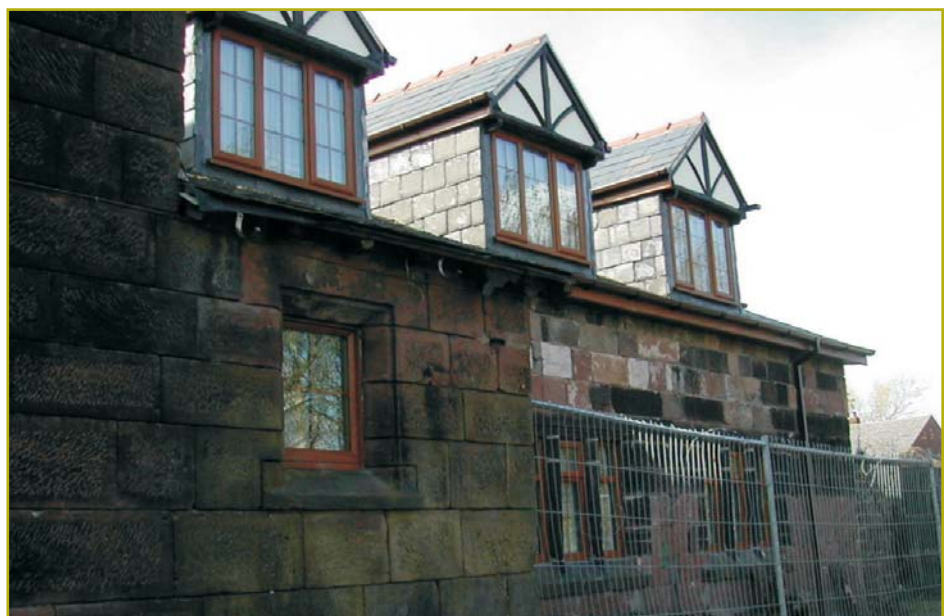
Figure 29: Examples of extensions and additions to older buildings that have changed their character or setting

In addition, a few unsympathetically constructed porches can be found within the village, although most of these are onto the sides of buildings. Roof extensions to provide attic space can have a detrimental effect in unbalancing an otherwise rhythmic group of houses or causing an interruption to the roofscape within a street scene. The degree to which this will be detrimental depends of the materials and design chosen. Flat roofed dormers are more likely to have a higher impact than a series or smaller dormers designed to match the style of the original building or conservation rooflights.

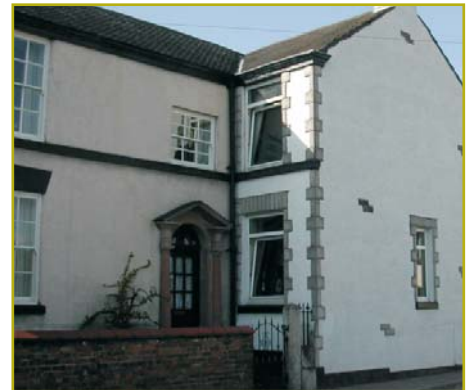
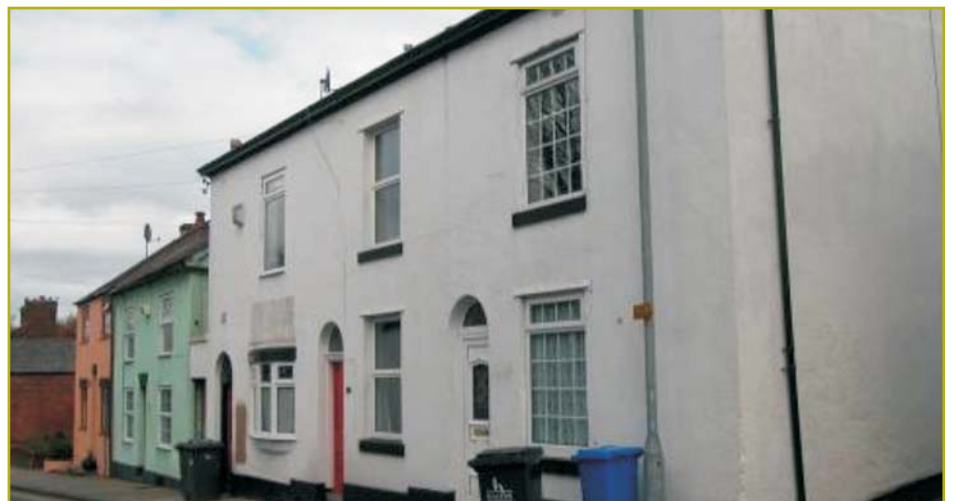
Windows: Replacement of original windows is a particular problem. Virtually none of the terraced housing along Main Street has their original sash windows and most have been replaced with UPVC or poor quality timber substitutes. In these dwellings little effort has been made to choose window types that match the original configuration of glazing bars – many are simply large picture windows with a small opening casement at the top. Changing the windows to UPVC presents visual problems, as the frames are considerably thicker than their timber counterparts and therefore

change the overall character of the window. Although there are a number of timber replacements, most of these are casements which also have a different appearance and many of these are stained, which although is potentially attractive on some modern buildings, is out of character and historically incorrect for a Victorian or Georgian building. Also, many replaced windows are positioned flush with the façade of the building (instead of a half brick back as was generally the custom) for ease of installation; this again changes the character of the building, particularly when viewed from the side, and therefore has a detrimental effect on the streetscape.

Figure 30: The effects of replacement UPVC windows on the character of buildings in the Conservation Area

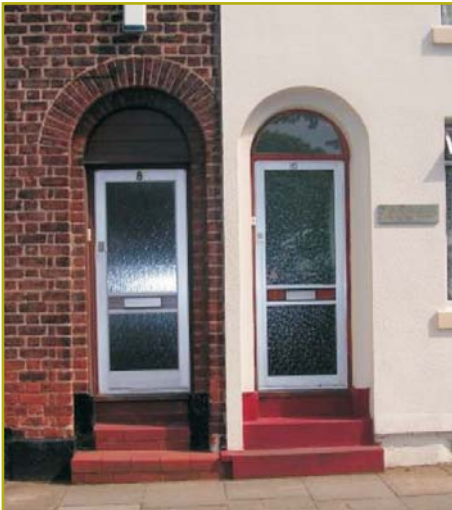
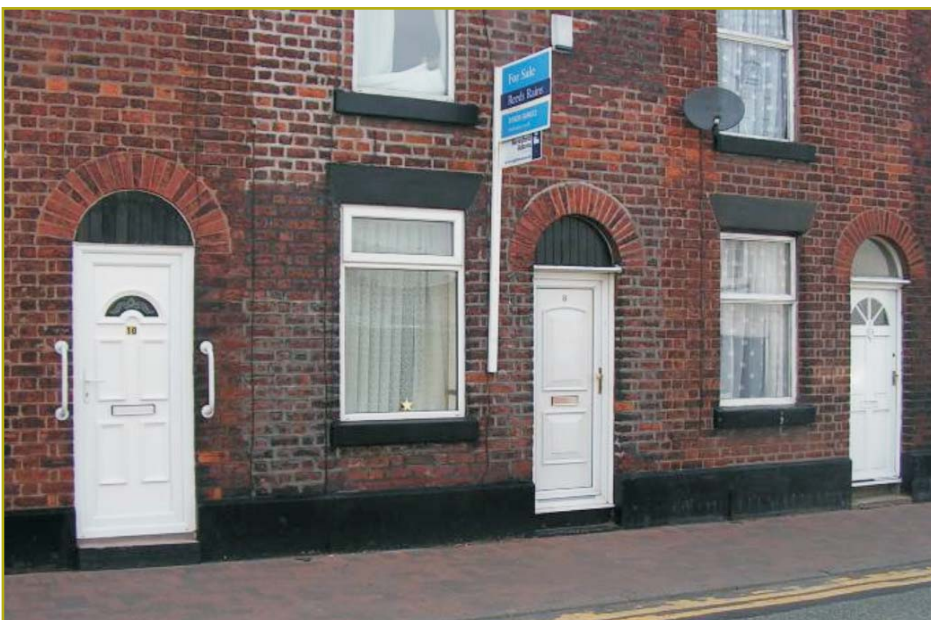
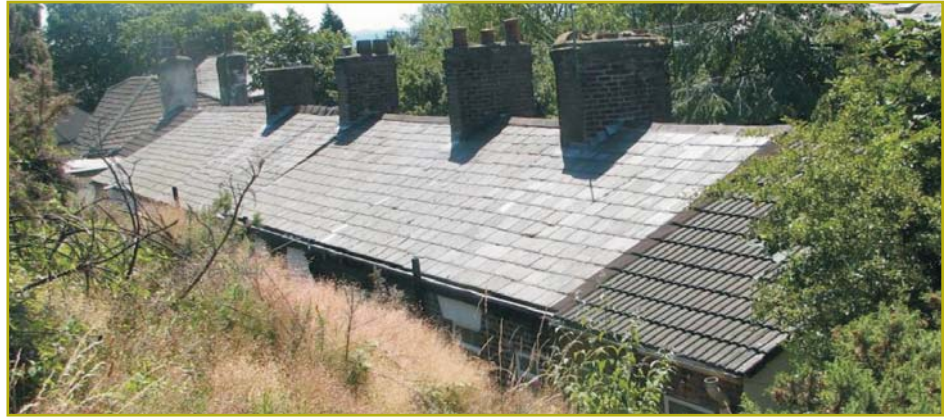
Doors: The replacement of doors is a similar issue to that of windows, as they are a critical part of the character of a building and they contribute to the rhythm and unity of a group of buildings. Mass produced 'off the shelf' doors are unlikely to reflect the character of the building, particularly when they are of UPVC as the availability of traditional colours is very limited.

Figure 31: The effects of replacement doors on the character of buildings in Halton Village

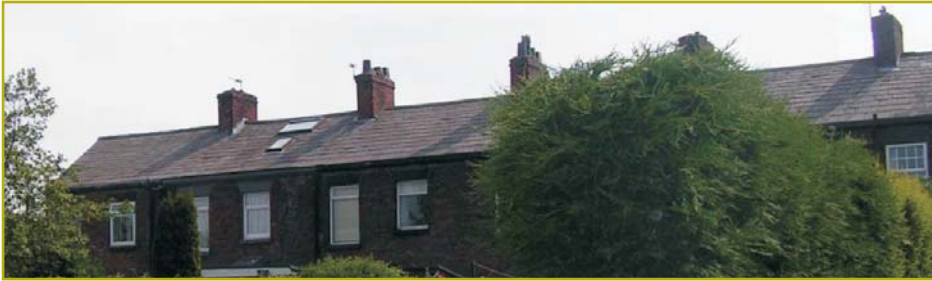
Rooflights: Where rooflights are detrimental to the character of the conservation area it is often because they are raised up from the level of the slates or positioned on an obtrusive roof slope. If specialist conservation rooflights are fitted flush with the slates or tiles, the visual effect can be minimal. Rooflights can be particularly detrimental to the character of the area when they are located to the front of the building and can be viewed from the street level, or where they are located towards the rear of the building, and can be overlooked from the higher vantage point of Castle Hill. Further measures to reduce the detrimental effects of the fitting of rooflights are discussed further in the Management Plan.

Figure 33: The effect of rooflights on the roofscape of a row of terraced housing

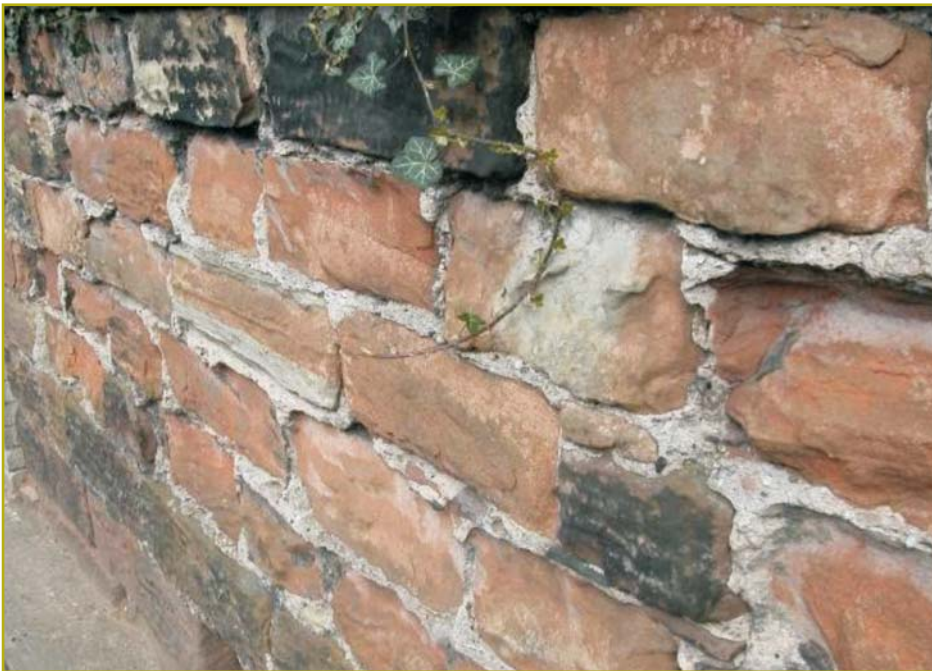
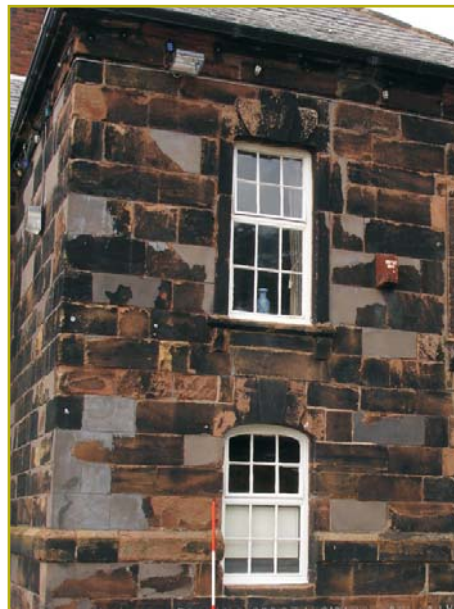
Figure 34: Examples of hard cement mortar damaging stonework: (above) Hard cementitious mortar joints damaging a stone boundary wall and (right) Damaging and unattractive cementitious render repairs

Poor repairs: There are a number of examples in the village where well-intentioned repairs are visually detrimental to the character of the building and are damaging the historic fabric. Most notable is the use of cementitious pointing and render on stone and soft brickwork. Local sandstone and brick older than 100 – 150 years of age are likely to be considerably softer than cementitious mortar. When rainwater inevitably

enters the surface of the building fabric it will find its easiest way out, via the softest material. In the case of a building pointed with a cement mortar, the water will find its way out through the brick, not the joints, which will over time, cause damage to the surface. There are also instances where stone walls are pointed with strap or ribbon pointing which is where the mortar extends over the face of the stonework. This both disguises the original appearance of the masonry and also will intensify the rate of erosion to the face of the stone. Another instance relates to the reconstruction and repair of gable end walls, where unsympathetic materials have been used in the process. This has resulted in a number of prominent poor quality facing walls within the Conservation Area, due to the layout of Halton Village.

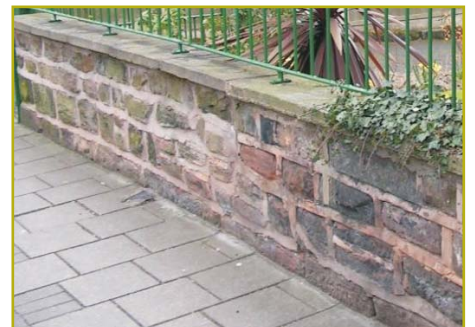
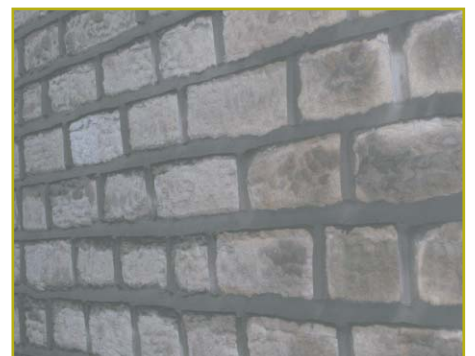
Figure 35: Examples of inappropriate pointing: Repointing of a sandstone wall where mortar joints appear over-dominant and strap or ribbon pointing

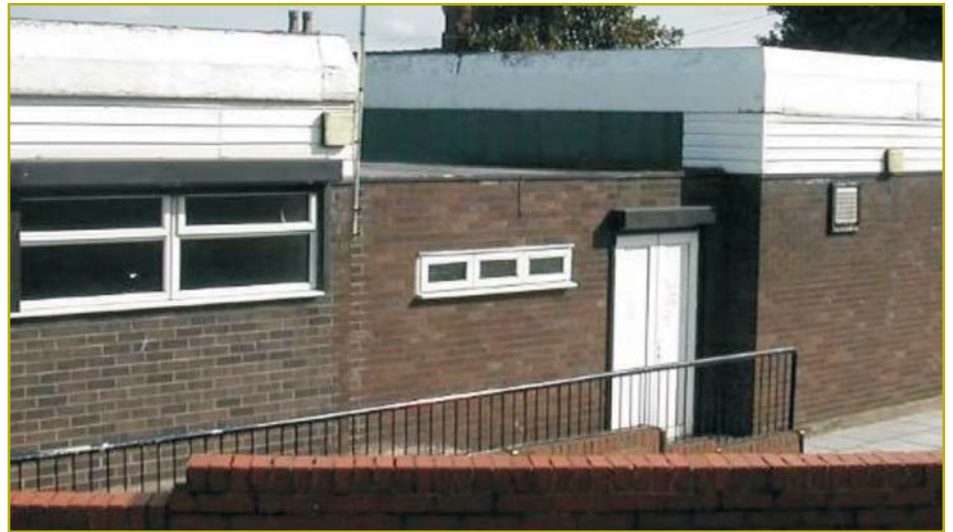
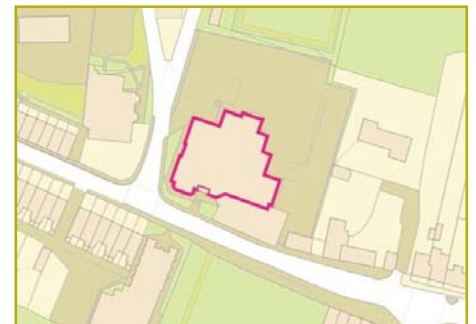
Figure 38: The existing British Legion Club on Main Street

The British Legion Club has many facilities that are of high benefit to the community but its more modern extension (on the junction between Main Street and Castle Road) and rear landscaping is identified within Part I of this report as being one of the most detrimental architectural elements within the village (see Appendix C). Should the opening arise, the opportunity should be taken to redevelop this part of the area with a British Legion building that adds to rather than detracts from the character of the Conservation Area. The extension to the British Legion

In order for buildings identified as being detrimental to the character of the Conservation Area to be replaced with more appropriate development, it may be in the Council's interest to draw up development briefs for

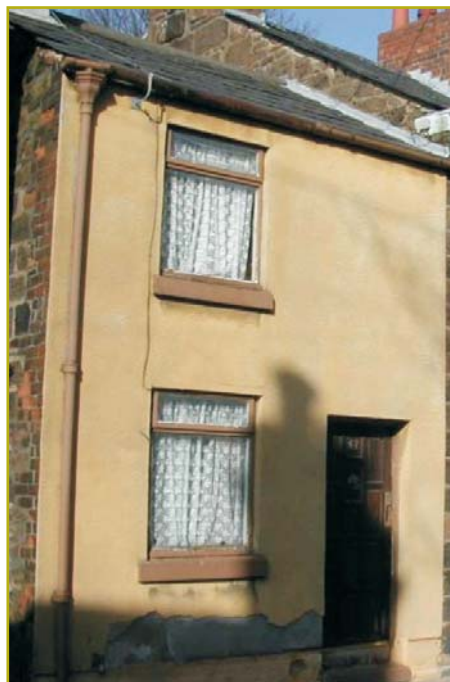
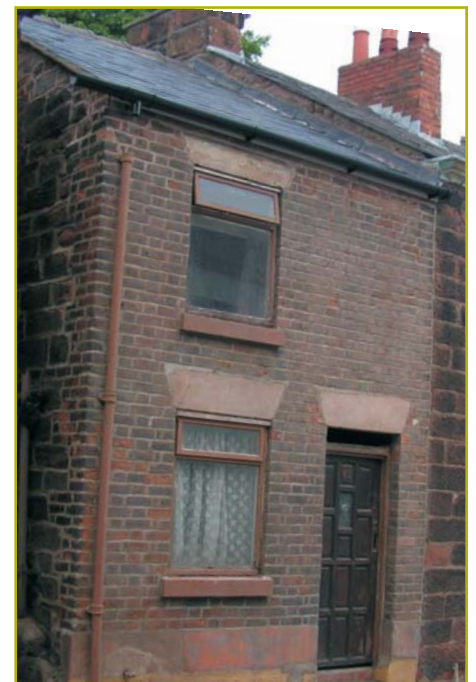
Figure 39: Effect of removing cladding from a terraced house on Main Street

Part I of this report identified a number of instances where poor quality repairs are detrimental to the condition and/or appearance of the historic fabric of a building or structure. One notable example of this problem is hard pointing to sandstone walls. Building owners should be encouraged to remove these poor quality repairs and repair with materials and methods that are appropriate to a historic building, and in consultation with a conservation professional.

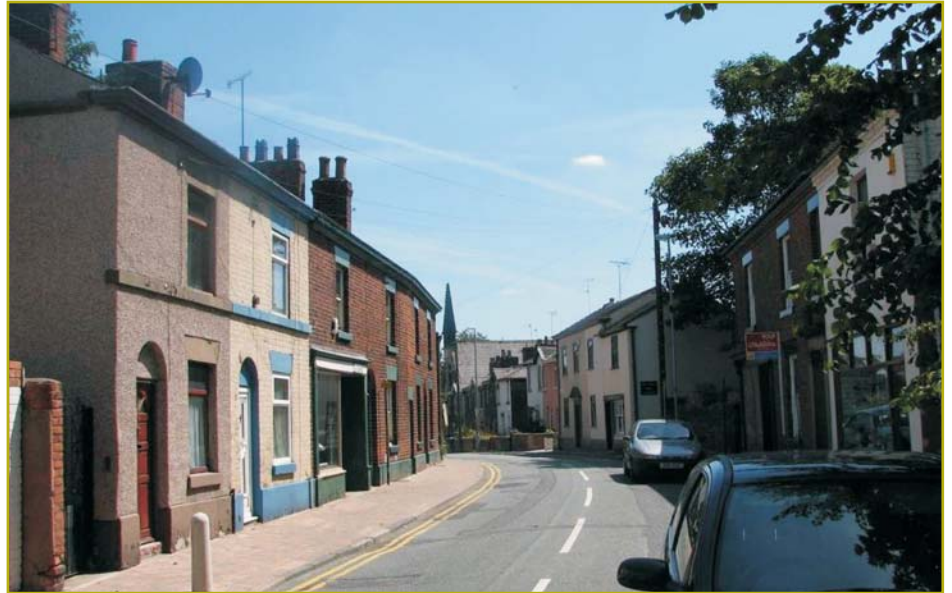
Figure 43: The effect of gradual changes to buildings along Main Street
